## knife Drive Rack DC Power Status Monitor & Capacitor Bleed Down System

Upgrade

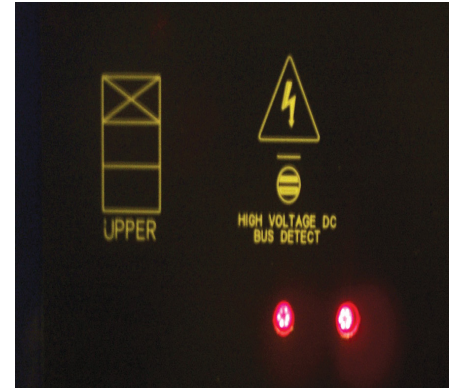
The drive rack DC power status monitor provides operator/maintenance personnel with a visual indicator which can be used to determine if the high voltage DC bus is present for each drive rack when machine power is applied. It also indicates if power has been dissipated after the machine is powered down.

The electronic drive rack capacitor bank regen/bleed-down system has proven to be more reliable than the older contactor-based circuit, and it functions even during machine power phase loss situations which can cause a contactor-based circuit to fail.
